ASSESSMENT REPORT FOR:

FRED C. UNDERHILL ELEMENTARY
HOOKSETT, NEW HAMPSHIRE

TTG PROJECT No: 4297

DATE: AUGUST 29, 2017

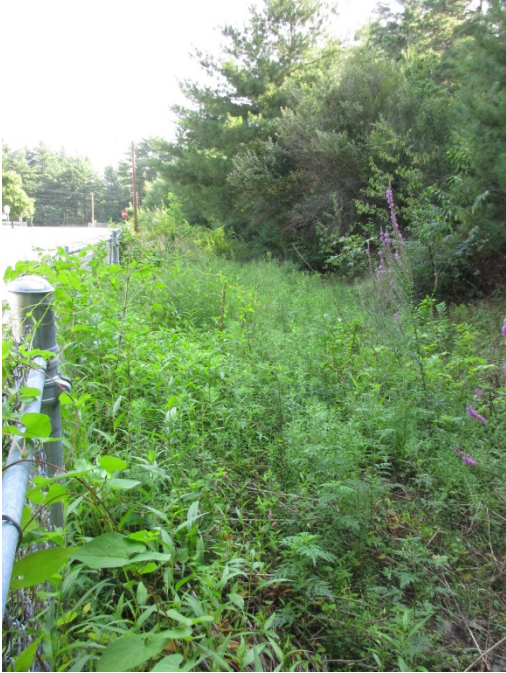
The stone-lined swale is overgrown with tall grass, small trees, shrubs, and other woody vegetation. The construction plans from 1990 indicate the tree line was cut back approximately 50-feet from the swale and the remaining slope was loamed and planted with grass. This encroaching vegetation minimizes the capacity of this swale to manage all of the runoff it is designed to accommodate. There is a perforated pipe underneath the swale designed to transport runoff to the infiltration basin. The roots of these plants can clog the pipe and the pores of the stone surrounding it, which can ultimately lead to the failure of this system.

Overgrown vegetation between parking lot and swale along south side.

- Remove trees, shrubs, and woody vegetation from the stone-lined swale along the edge of pavement on the south side of the school, and perform regular maintenance to ensure the swale remains clear. Mow the grass between this swale and the visitor's parking lot to ensure runoff can flow freely into the swale. Inspect the swale regularly for trash, debris, and sediment and remove any of these items that may be discovered.
- Install a stone drip edge (min. 4' wide and 12" deep) along the face of the foundation along the south side of the gym. Place a perforated pipe, sloped to drain, at the bottom of the stone and run it to an infiltration basin located at least 10-feet away from the building. The purpose of the drip edge is to capture roof runoff and prevent it from seeping into the ground against the foundation.

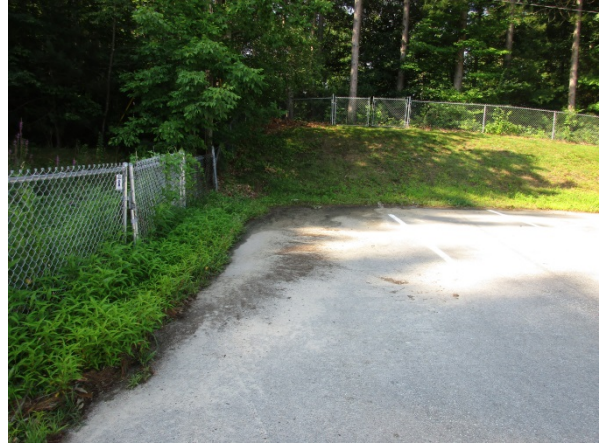
Sediment in southwest corner of parking lot indicating area where runoff ponds.

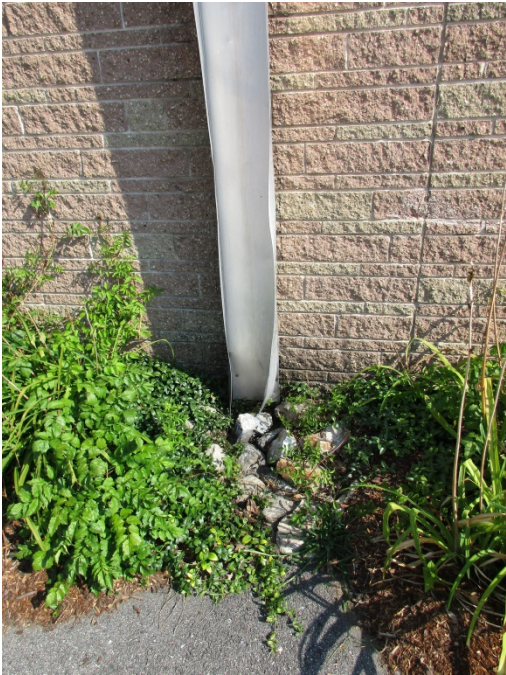
Runoff from the gymnasium roof flows through two roof drains mounted to the exterior wall of the building and discharges onto the ground next to the school foundation. It appears the original intent was to allow this runoff to flow across the visitor parking lot toward the swale, but the location where these drains daylight has settled, and is lower than the edge of pavement. Roof runoff does not flow across the lot until it ponds to a depth of a few inches and until that happens it infiltrates into the ground adjacent to the gymnasium foundation. It is desirable to transport runoff away from building foundations, even if there is no basement present. Allowing roof runoff to flow across parking areas can lead to hazardous icing conditions during freeze/thaw seasons. According to the 1990 construction plans provided to TTG it appears the original intent was to have a landscaped area along the south face of the exterior gymnasium wall, but in the current condition it is paved almost to the face of the concrete foundation.

Roof leader along south face of gym.

| CIVIL/SITE | | | \$ Opinion of Cost | | | |
|---|---|---|---|---|---|---|
| Roof leaders on south wall of gymnasium. | Leaders discharge direct to the ground with the intention of allowing runoff to flow across parking lot to swale. | Install a stone drip edge along the gym foundation to contain runoff and prevent it from flowing across the parking lot. Include a perforated pipe to carry the runoff away from the foundation to an infiltration structure or to daylight away from the building. | 3-5 years | | \$15,000 | |

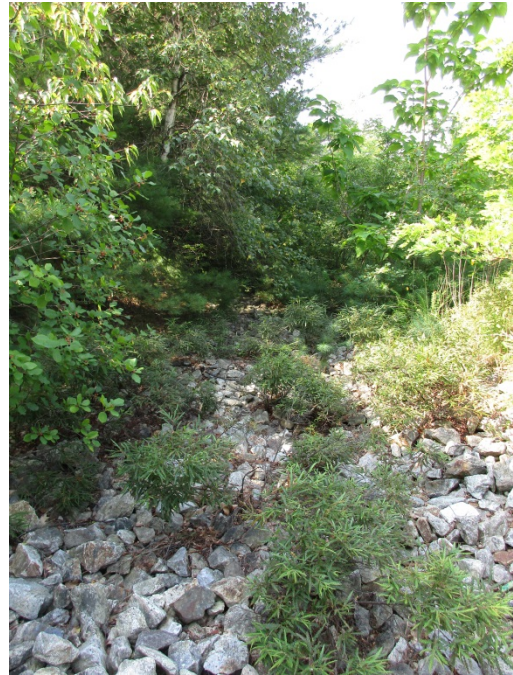
Excessive vegetation in drainage swale.

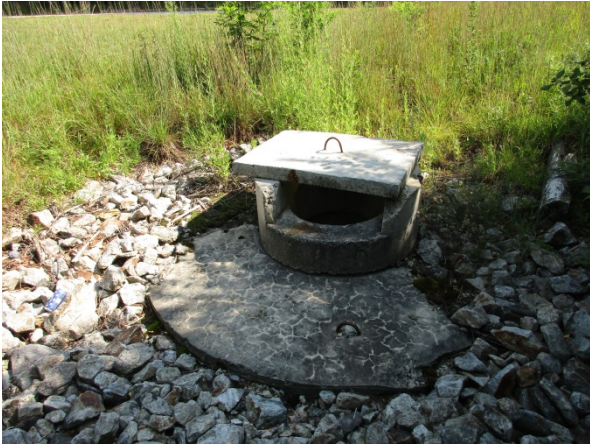
The infiltration structure adjacent to the entrance to the site has a large above-grade opening: It appears the original inlet opening was smaller but some of the concrete has broken and created a larger entrance to the structure. This opening is large enough for a child or animal to crawl through, which presents a hazard because the interior of the structure is over 6-feet deep and is designed to fill with water while slowly releasing it during rain events.

Inlet to infiltration basin adjacent to main driveway entrance to site.

| CIVIL/SITE | | | \$ Opinion of Cost | | | |
|---|---|---|---|---|---|---|
| Precast infiltration basin adjacent to driveway entrance to site. | Opening is larger than necessary and poses a hazard to children who could crawl into the structure. | Replace the basin inlet to allow runoff to enter the structure while preventing unauthorized access to its interior. | <3 years | \$3,500 | | |

- Install a new cover on the infiltration basin adjacent to the main driveway entrance to the site. The opening should have grating or consist of multiple smaller openings to prevent accidental access.

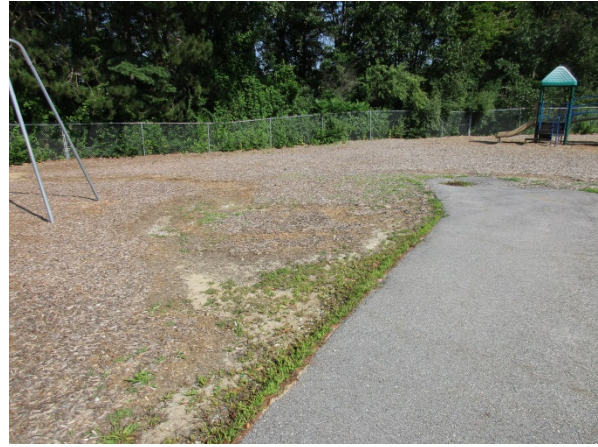
Erosion through playground mulch- note catch basin inlet at corner of asphalt.

| CIVIL/SITE | | | \$ Opinion of Cost | | | |
|---|--|--|---|---|---|---|
| Hardscaped playground | Runoff flows off the edge of pavement and causes erosion across the playground. There is an existing drainage structure at the corner of the paved area but most of the runoff flows off the pavement prior to reaching the inlet. | Install a bituminous curb along the west edge of the hardscaped playground area to direct runoff to the existing catch basin inlet. | 3-5 years | | \$3,000 | |

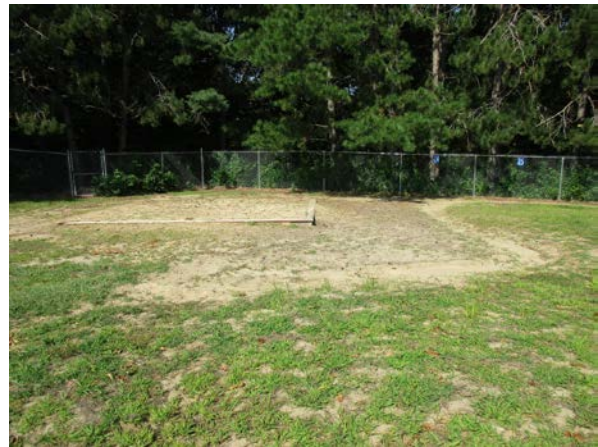
Erosion through sandy playground soil.

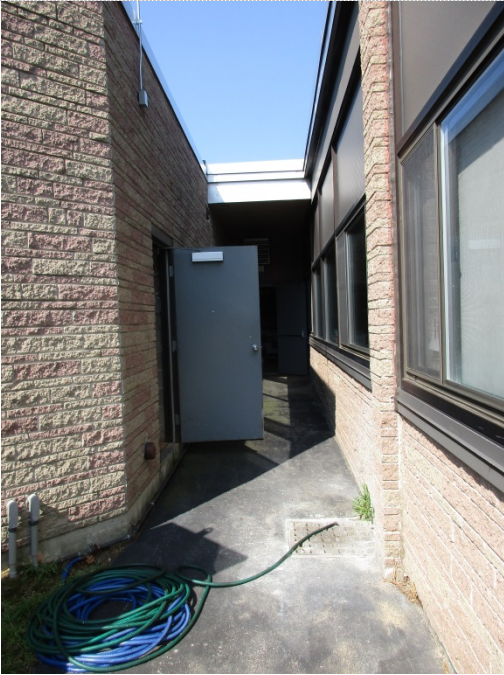
Catch basin in corridor outside of electrical room.

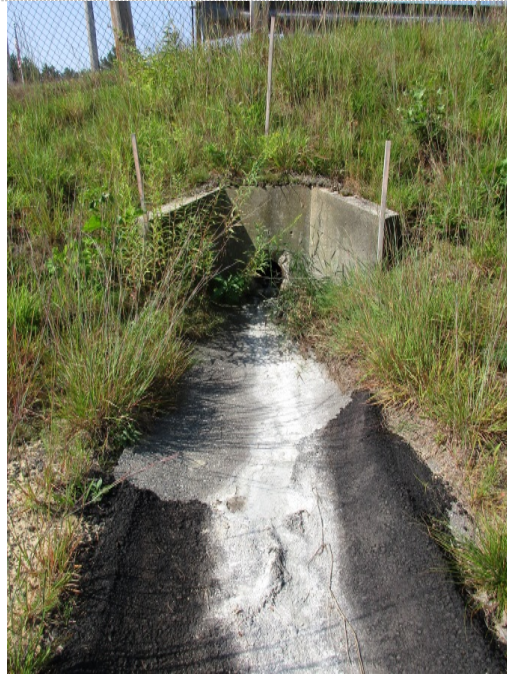
Culvert outlet from catch basin at electrical room..

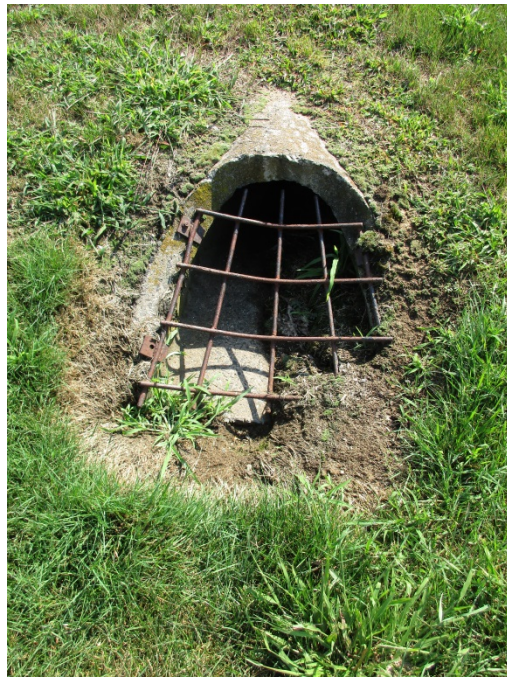
The grass-covered area in the middle of the bus loop is designed to capture runoff and direct it toward a concrete culvert that is tied into the infiltration basin described earlier (in the 'South Side' Drainage section), located adjacent to the driveway entrance to the site. Some of the surrounding soil has fallen into the inlet, reducing its available capacity, and there is some undermining at the pipe inlet.

Culvert inlet at center of bus loop.

| CIVIL/SITE | | | \$ Opinion of Cost | | | |
|--|---|--|---|---|---|---|
| Culvert inlet from bus loop island | Soil has partially obscured the intake to this inlet and there is some undermining of the concrete apron. | Remove soil from culvert intake and place compacted gravel to repair the undermined portion. Stabilize the earth on either side of the inlet with loam and seed. | <3 years | \$1,500 | | |

- Remove soil from the inlet of the concrete culvert from the landscaped area at the bus loop to the infiltration basin. Stabilize the material at the inlet of the culvert to ensure it does not become undermined.

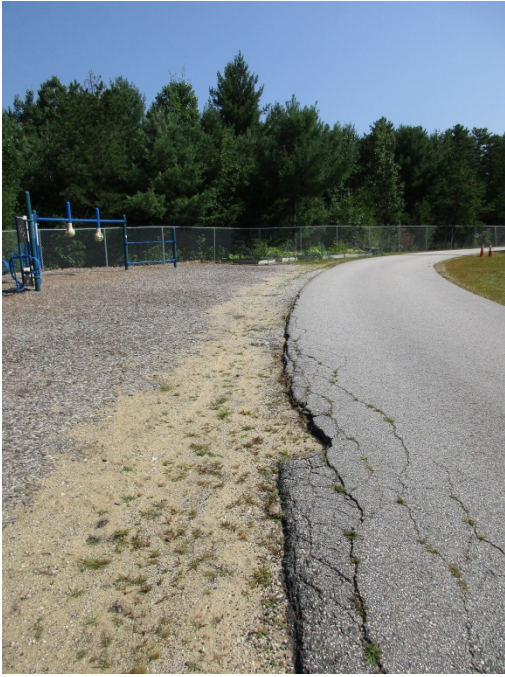
Undermining at edge of pavement. Add crushed gravel to stabilize edge and direct runoff away.

- Develop a pavement maintenance program. Clean and seal all existing cracks and sealcoat the entire site. Perform these actions on a regular basis.
- Place and compact bank run gravel (NHDOT 304.2) at the edges of pavement where the shoulders are eroding, to prevent undermining of the asphalt.

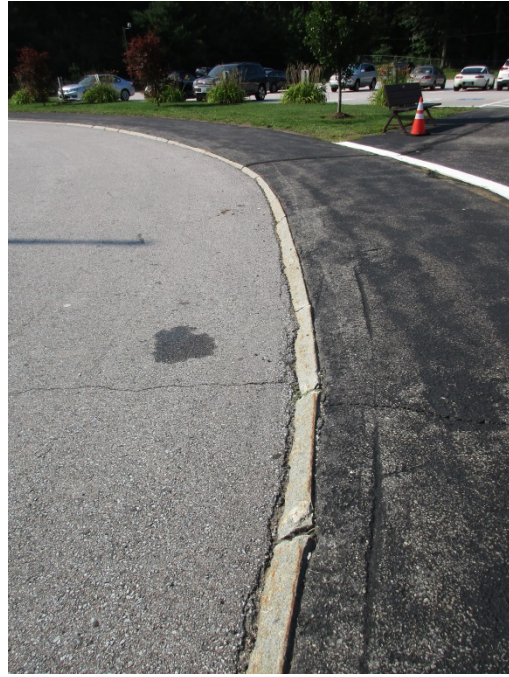
Much of the sloped granite curbing at the bus loop is broken and displaced. It should be extended the full length of the bus loop, to the radius at the intersection with the driveway to the visitor parking lot. There is no need for a sidewalk tip down at this intersection because there is no pedestrian route across the driveway here.

Displaced sloped granite curb at bus loop.

| CIVIL/SITE | | | \$ Opinion of Cost | | | |
|---|--|---|---|---|---|---|
| Sloped granite curbing | This curbing is broken and displaced in many locations. There is minimal vertical reveal (<3"). | Remove and reset sloped granite curbing. Ensure it is set true to line and grade and with at least 4" of vertical reveal. Extend curbing at bus loop to the intersection with the driveway leading to the visitor parking lot. | >5 years | | | \$15,000 |

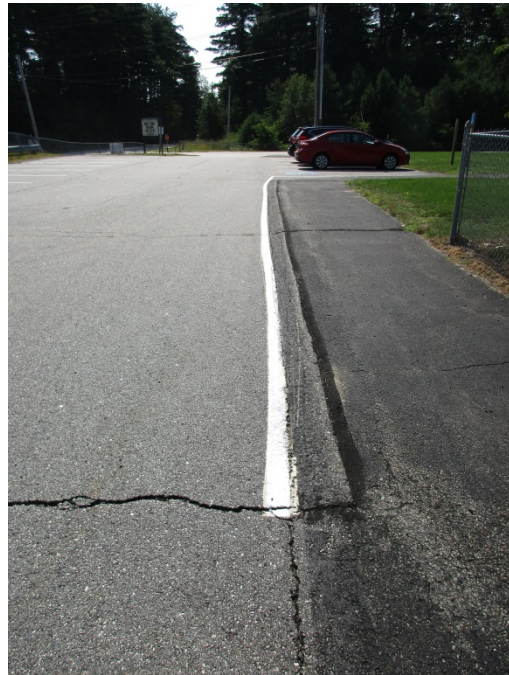
Bituminous curb with minimal reveal. Place stripe along top edge of curb. Note cracks in sidewalk and driveway.

| CIVIL/SITE | | | \$ Opinion of Cost | | | |
|---|--|--|---|---|---|---|
| Bituminous curbing. | Some of the curbing is cracked and broken and there is minimal vertical reveal (<3"). There is no visual indicator along the top of the curb to delineate its presence. | Replace bituminous curbing. It makes sense for the district to combine this effort with a sidewalk replacement program. New curbing should have a minimum vertical reveal of 4" and the district should paint a 4" wide yellow or white line along the top of the curb. <i>(Note: The district may opt to paint a stripe now as a short term measure to provide delineation)..</i> | >5 years | | | \$15,000 |

- Replace bituminous curbing when the sidewalks are repaved. There should be at least 4-inches of vertical separation between the vehicle and pedestrian surfaces and paint a 4-inch white or yellow stripe at the top edge of the curb.

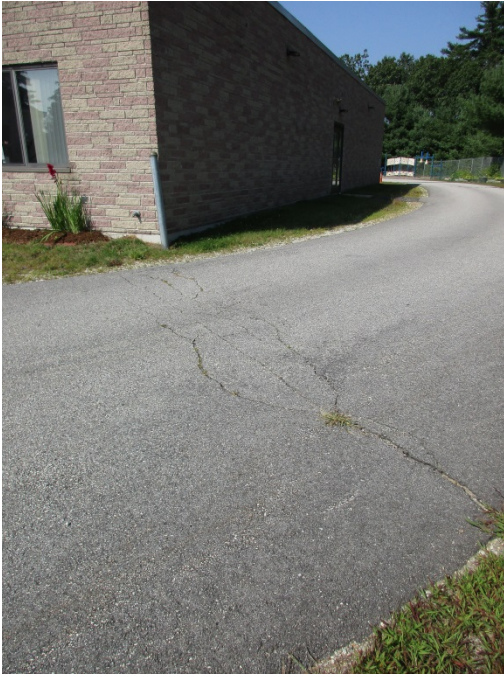
The pavement across the entire site is in fair condition. There is some stress cracking but no more than what one would expect for its age. Evidence of preventive maintenance measures (crack sealing) are evident but the work is not recent.

Crack in driveway pavement (typical example).

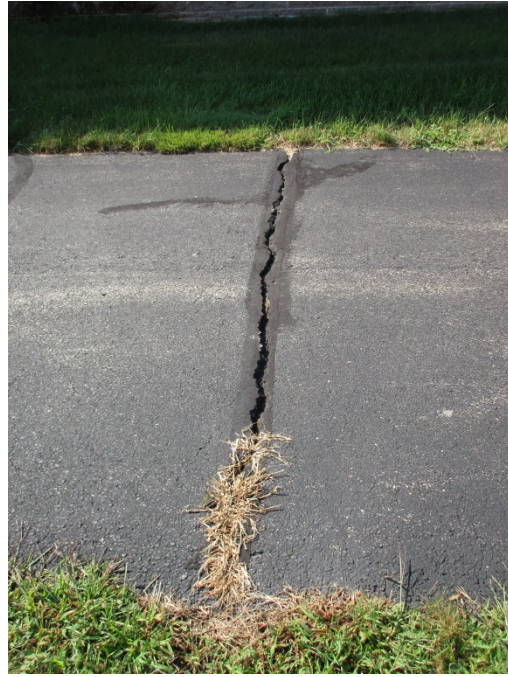
Sidewalk crack. Note evidence of previous repair.

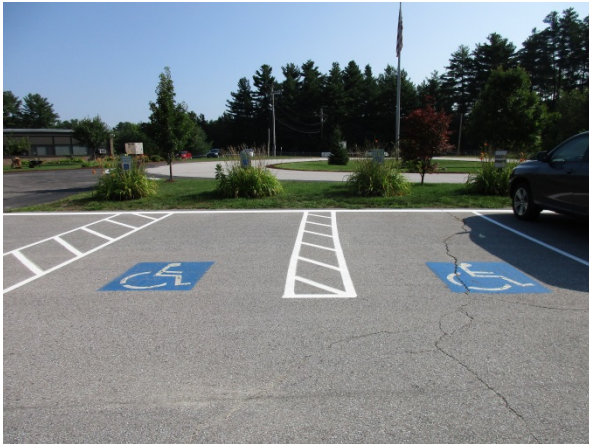
Noncompliant accessible spaces: Aisles are too narrow and signage is mounted too low. No indication of van accessibility.

| CIVIL/SITE | | | \$ Opinion of Cost | | | |
|---|--|--|---|---|---|---|
| Accessible parking signage | There should be a minimum of 5-feet between the bottom of the signage and the ground. | Replace the sign posts and mount the accessible signage in accordance with ADA standards. Include 'Van Accessible' signs at the appropriate spaces. | <3 years | \$2,500 | | |

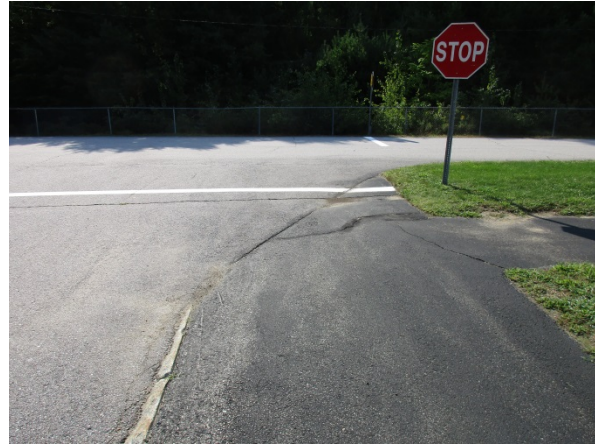
Extend sloped granite curb around corner of intersection. Sidewalk tip down not required because there is no pedestrian crossing. Note low mounting height of stop sign.

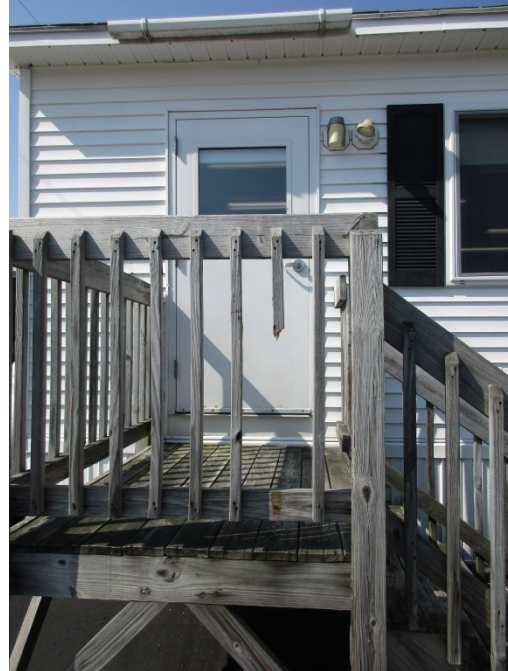
Repair broken baluster (per the previous note, the entire stair case should be replaced to comply with ADA regulations).

- Replace wooden stairs and railings leading to the portable classroom.

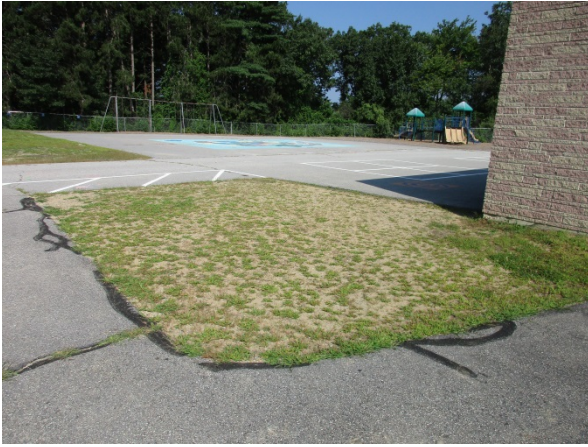
Sparse vegetation on west side (typical)

- Place 6- 8-inches of loam across the landscaped areas on the west side of the building and seed it with a dense-growing grass. Maintain the grass with regular mowing and reseeding bare areas when they begin to develop.
- Prune or remove vegetation that is overgrown, particularly trees and shrubs growing directly against the exterior walls of the building.
- Rake out mulch to expose the weep holes in the lowest masonry courses.
- Refer to the recommendations in the 'Drainage' section to address overgrowth in the stone swale.

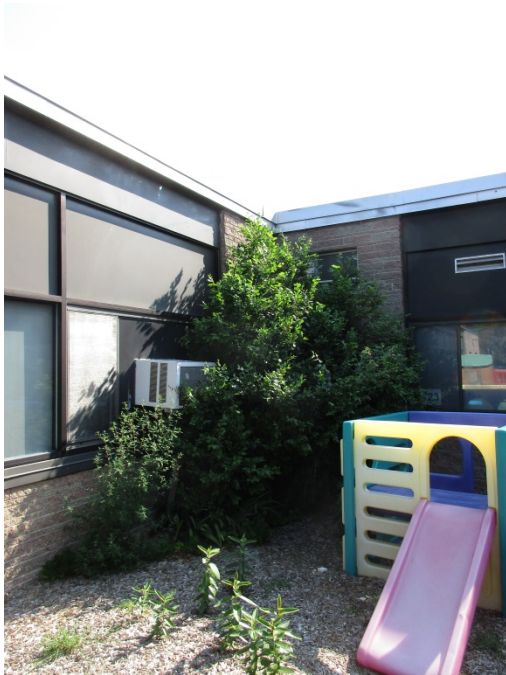
In a few locations, there are some trees or woody vegetation growing against the exterior walls of the school. At the corner of the fenced-in courtyard on the west side of the school there is a tree that is overgrown and obscures windows and an air conditioning unit.

Overgrowth in courtyard.

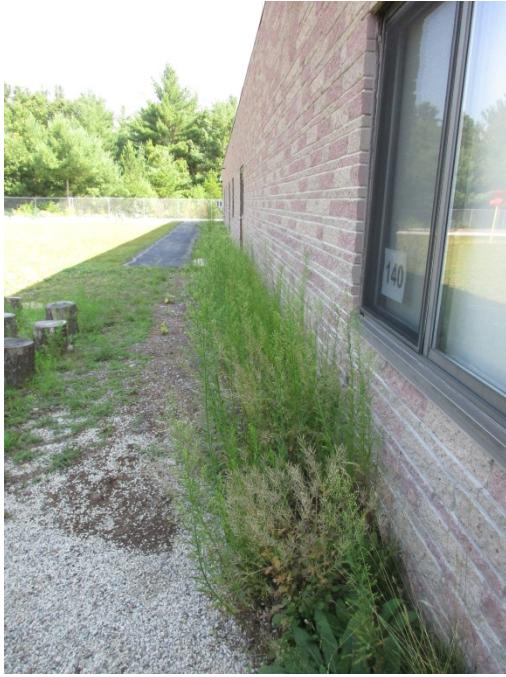
Overgrowth along foundation (typical of multiple locations)

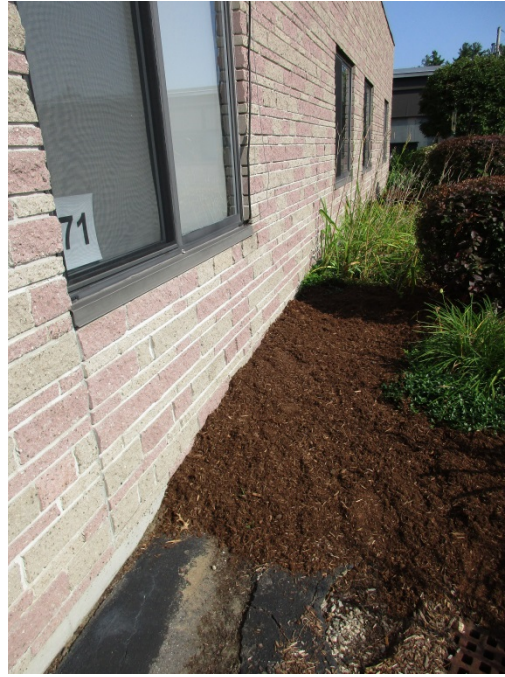
In the landscaped beds adjacent to the foundation, in several locations the mulch is mounded over the lowest courses of masonry, which can prevent water from being able to drain out of the interior wall cavity.

Landscape bed obstructing masonry weep holes at lowest courses.

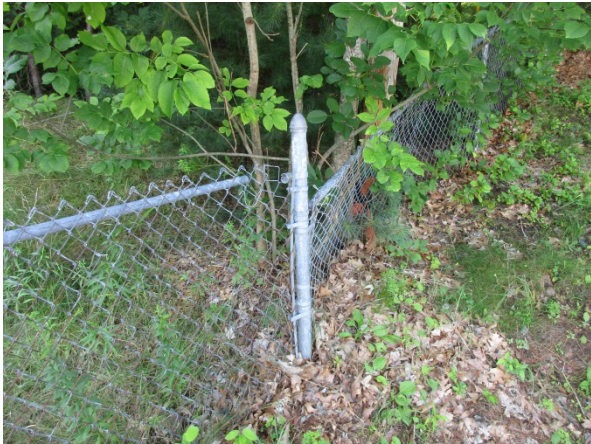
The chain link fencing throughout the site is in fair condition but in a few locations, the components have slipped out of their connections and fittings, and some lengths of fence are out of plumb.

Example of chain link fence section to be repaired
(this location is at the southwest corner of the visitor
parking lot).

| CIVIL/SITE | | | \$ Opinion of Cost | | | |
|---|--|---|---|---|---|---|
| Chain link fence | The fence is in decent condition but there are some areas where the connections have come loose and where the sections are out of plumb. | Repair the existing fence as required and reset areas that are not plumb. | 3-5 years | | \$6,000 | |

- Repair and reset the chain link fence as needed.
- Install an 8-inch thick (minimum) dumpster pad with a concrete approach apron to support the weight of a garbage truck when it elevates the dumpster to empty it. Install an enclosure fence (wood stockade or chain link with privacy slats) around the dumpster to provide visual screening and containment for trash.

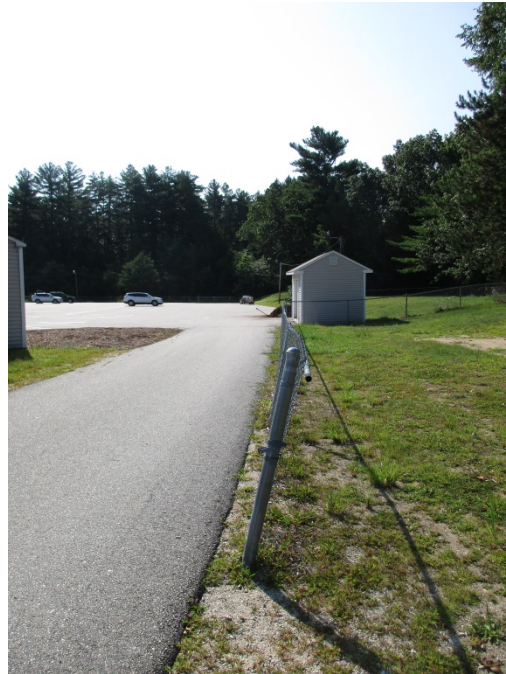
Displaced fence.

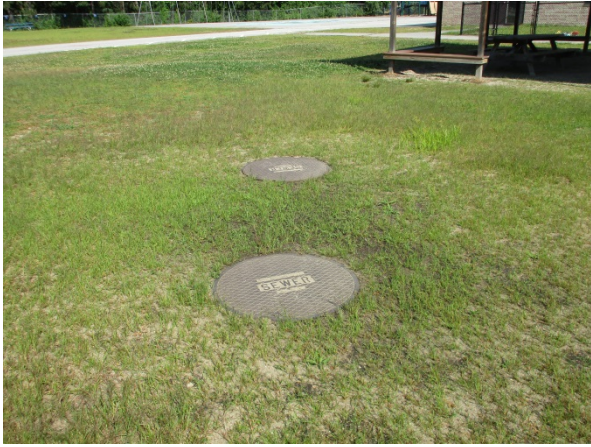
The sewer manhole covers at the grease interceptor on the west side of the school set slightly lower than the surrounding ground and it appears water ponds around one of the covers. This is a potential opportunity for rainwater to infiltrate into the sewer system.

Grease interceptor manhole covers. Note staining around cover in foreground, indicative of puddling water.

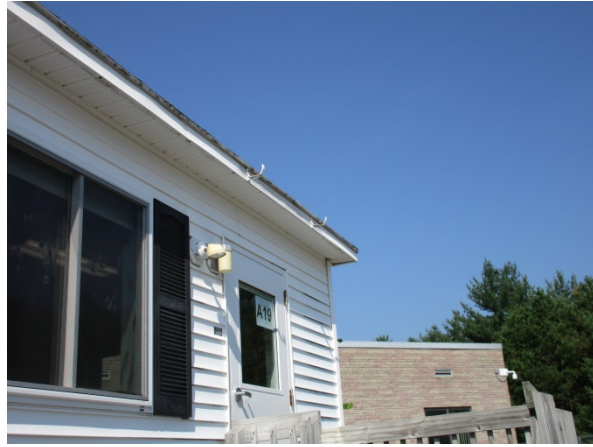
The rain gutter over the northernmost stair landing at the portable classroom is missing.

Missing rain gutter at portable classroom entrance.

| CIVIL/SITE | | | \$ Opinion of Cost | | | |
|---|--|---|---|---|---|---|
| Northern entrance to portable classroom | The rain gutter over the stair landing is missing. | Replace the gutter. | <3 years. | \$100 | | |

- Replace the rain gutter at the entrance to the portable classroom.
- Remount the stop signs so the bottoms of the signs are at least 6-feet above grade.

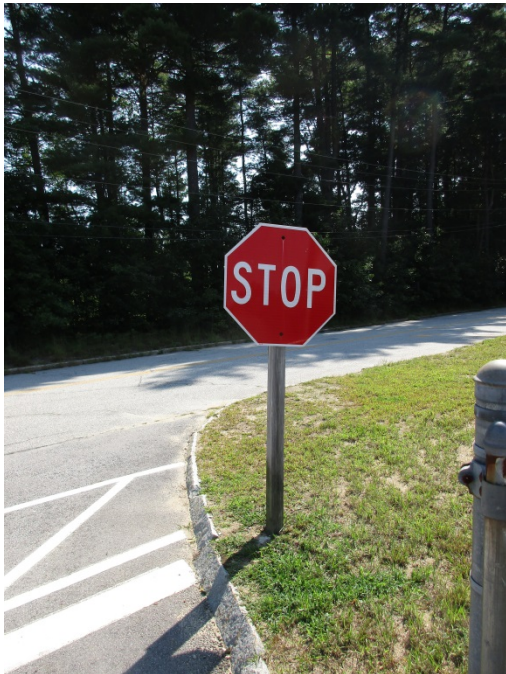
Stop sign mounted too low (typical for 3).

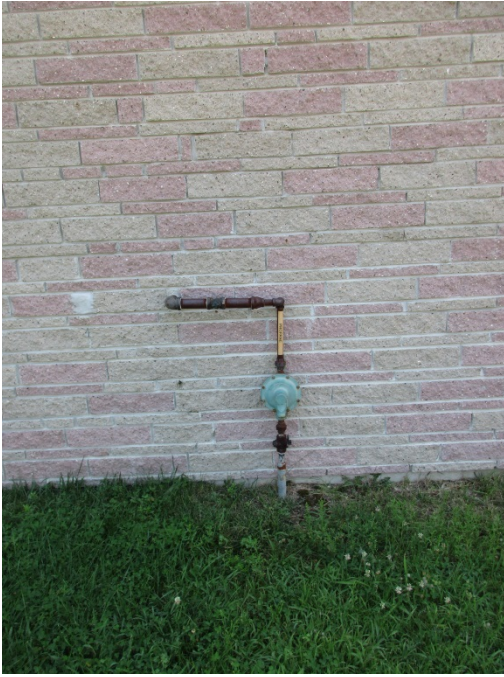
Unprotected propane regulator valve.

| CIVIL/SITE | | | \$ Opinion of Cost | | | |
|---|---|---|---|---|---|---|
| Propane tank risers and regulator. | The regulator is unprotected from impacts (i.e. a mower) and a vehicle could inadvertently hit the risers. | Place additional boulders, concrete filled steel bollards, or similar measures to provide additional protection for the propane delivery system. | <3 years | \$2,500 | | |

- Install concrete-filled steel bollards or similar impact protection at propane regulator and tank risers.
- Repair broken concrete door pad at pathway from school building to portable classrooms.

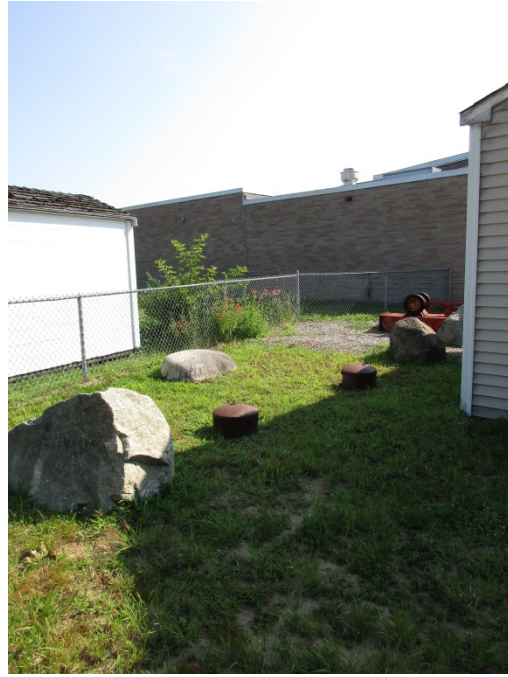
Provide additional protection for propane tank risers to the right of the boulder in the foreground.

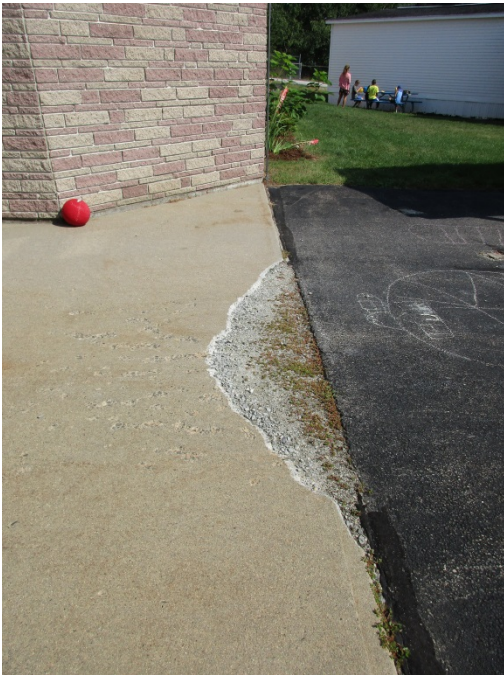
At the egress door leading to the portable classrooms, the concrete door pad has a large broken section and should be repaired to prevent further damage.

Broken concrete at door pad near portable classrooms.

| CIVIL/SITE | | | \$ Opinion of Cost | | | |
|---|---|---|---|---|---|---|
| Concrete door pad | The concrete at the door landing leading to the portable classroom ramp has a large portion of it that has broken away. | Repair the concrete door pad. | <3 years | \$3,500 | | |

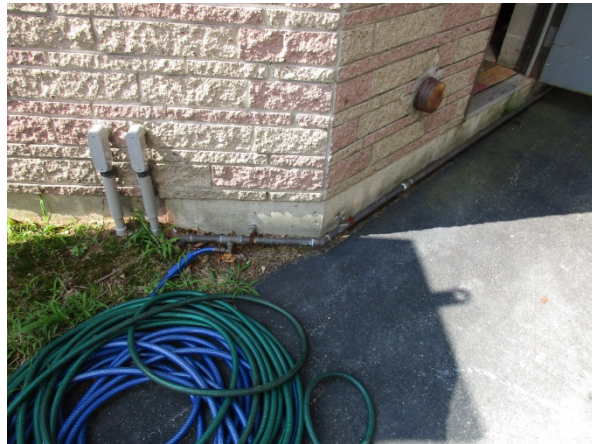
There is an exposed water line running aboveground in the exterior corridor near the electrical and mechanical rooms. This is at risk of damage if water in the line freezes. The school should consider reinstalling this line underground to the building (6-feet below grade) and provide an exterior sill cock for a hose connection.

Exposed exterior water line.

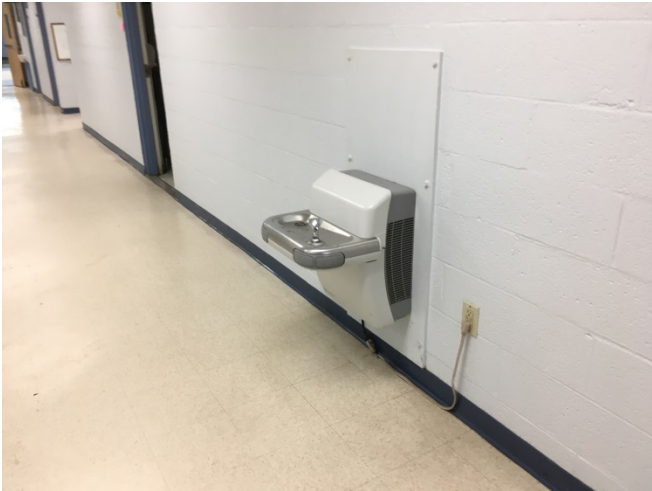
Drinking Fountain Trip Hazard.

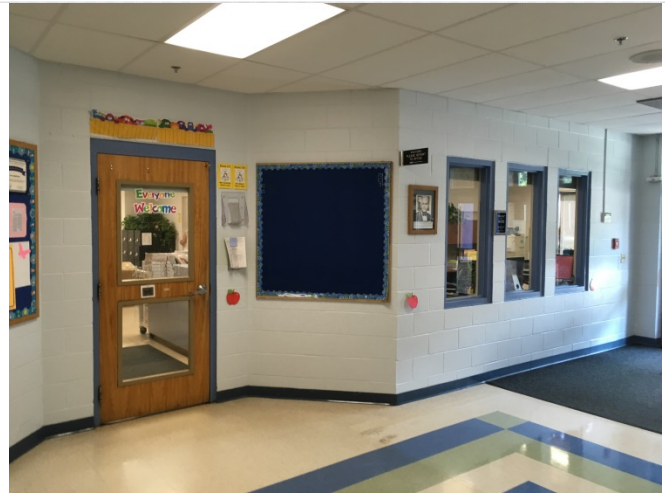
Unsecure Main Office Access

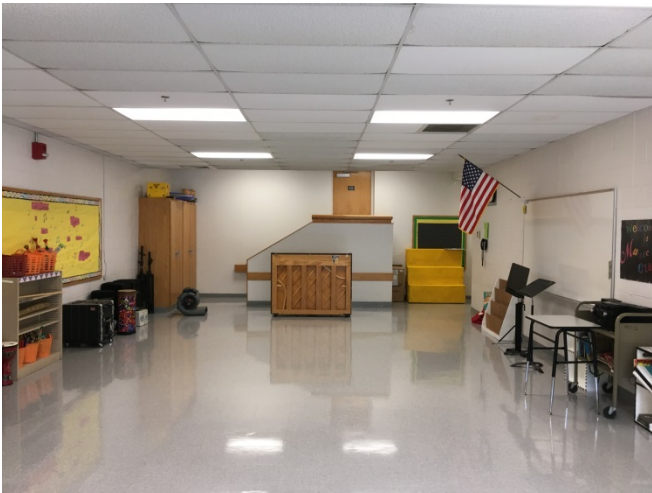
Sagging ceiling tiles.

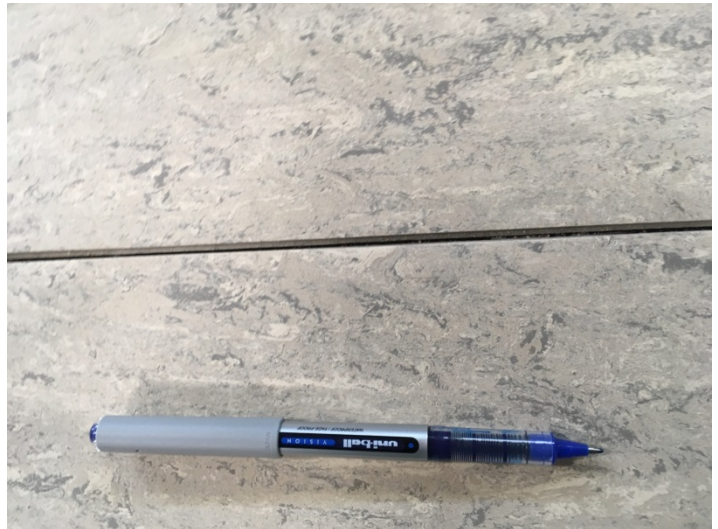
Gaps in Gymnasium Flooring.

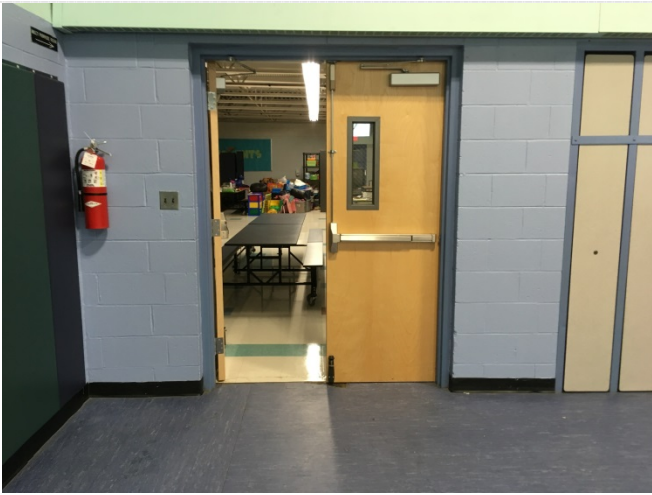
Non Compliant 2'-6" Door Leaves

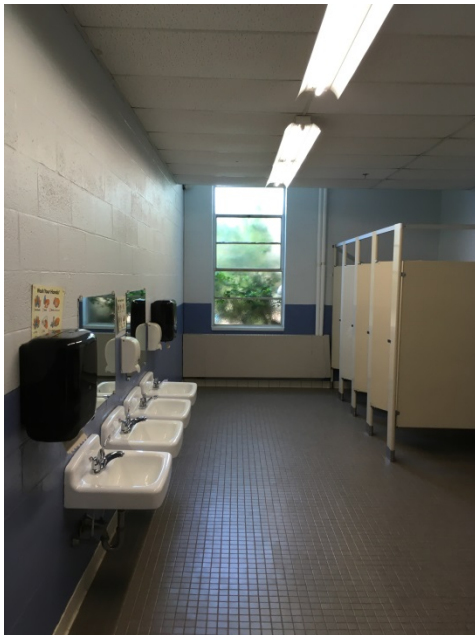
Dated Non Accessible Restrooms

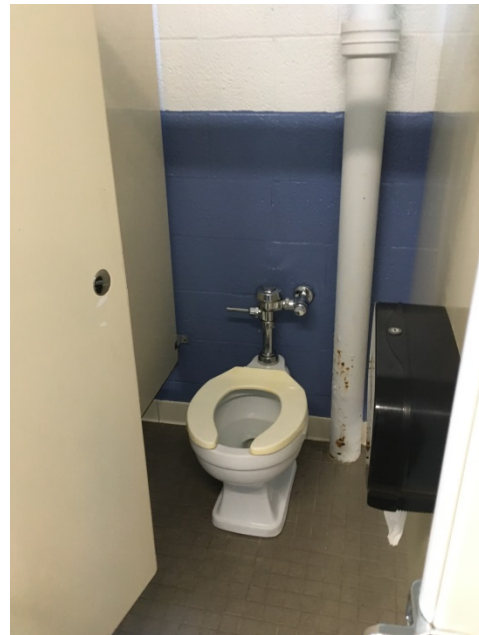
Dated Non Accessible Restrooms

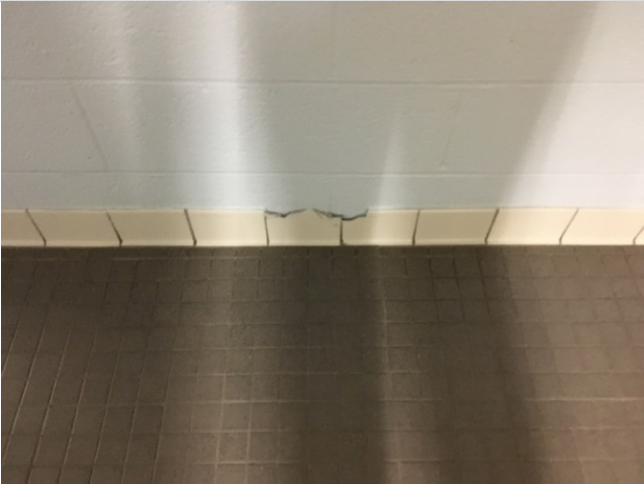
Dated Restrooms

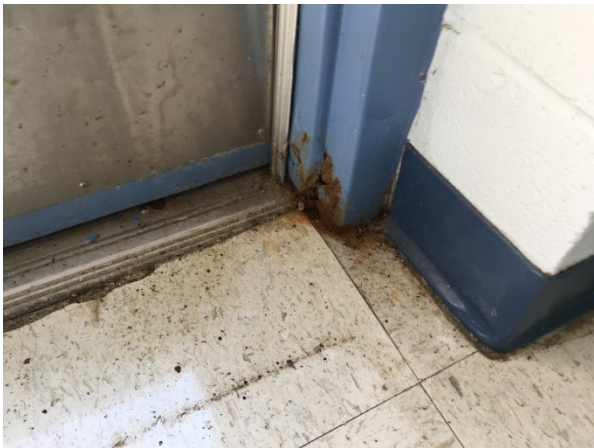
Rotted Door Frames & Damaged Tile

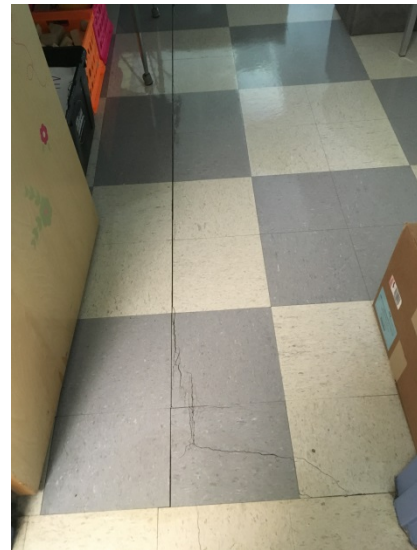
Tile Damage Example

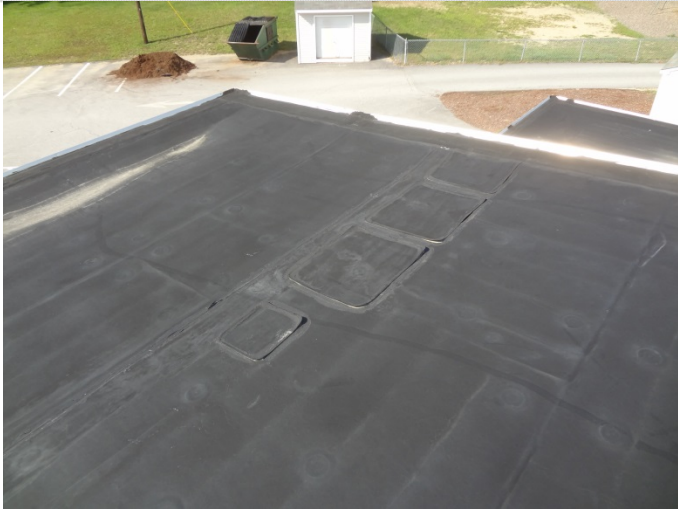
Patches on the Gym EPDM Roof

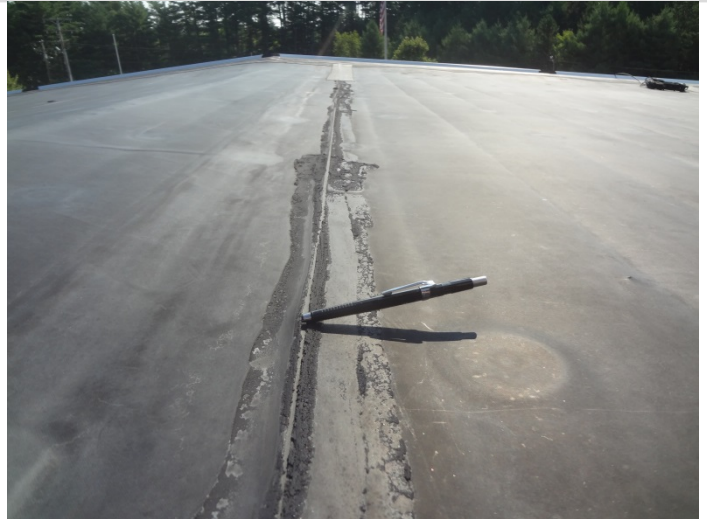
Seam on the Gym EPDM Roof

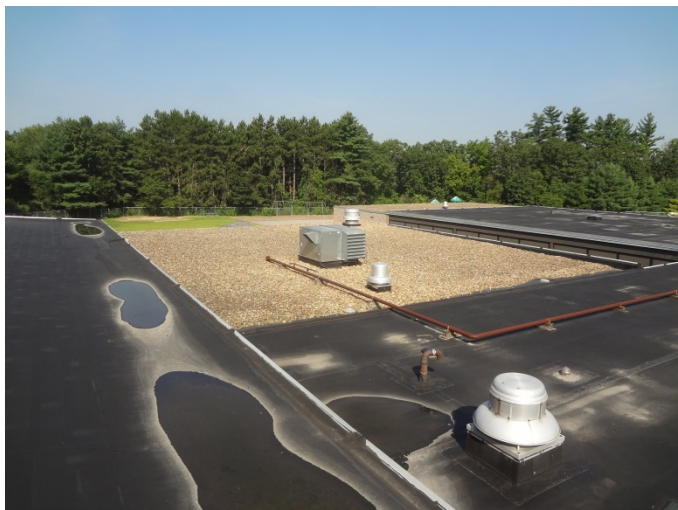
Ponding Along the Gym Roof Edge

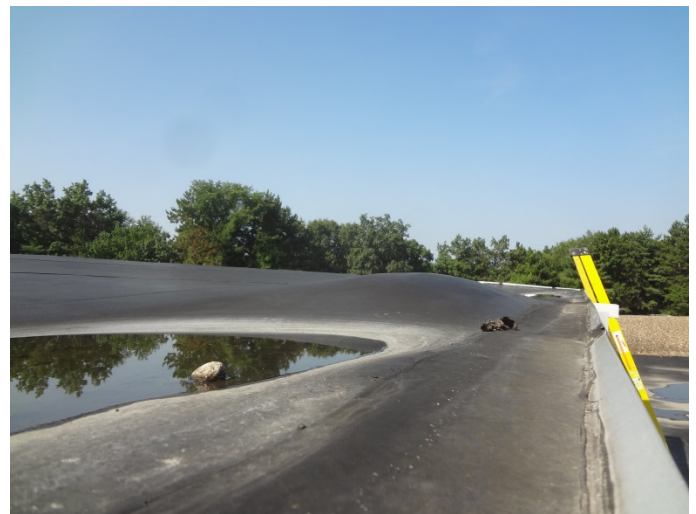
Bulge in Gym Roof

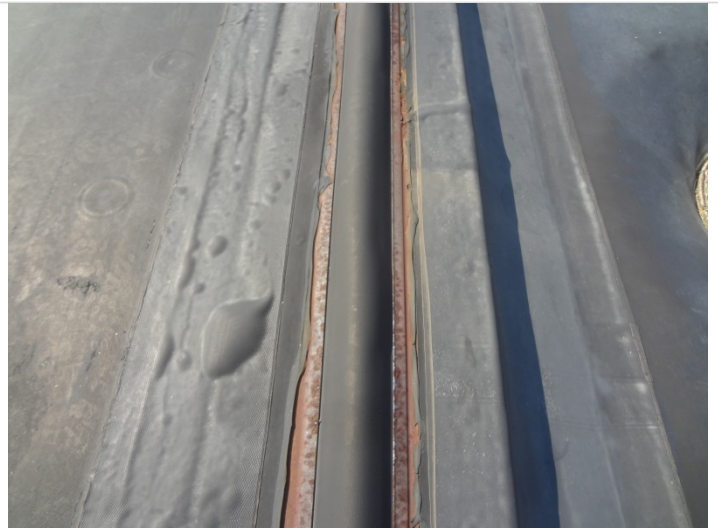
Rusted Roof Expansion Joint

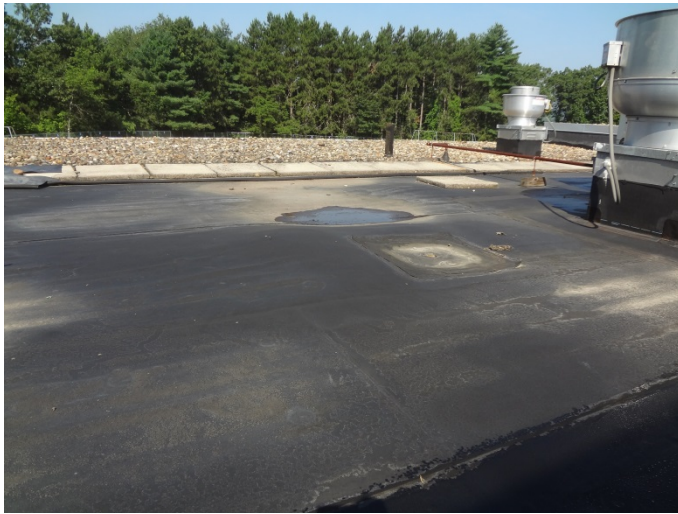
Bulge in Kitchen Roof Membrane

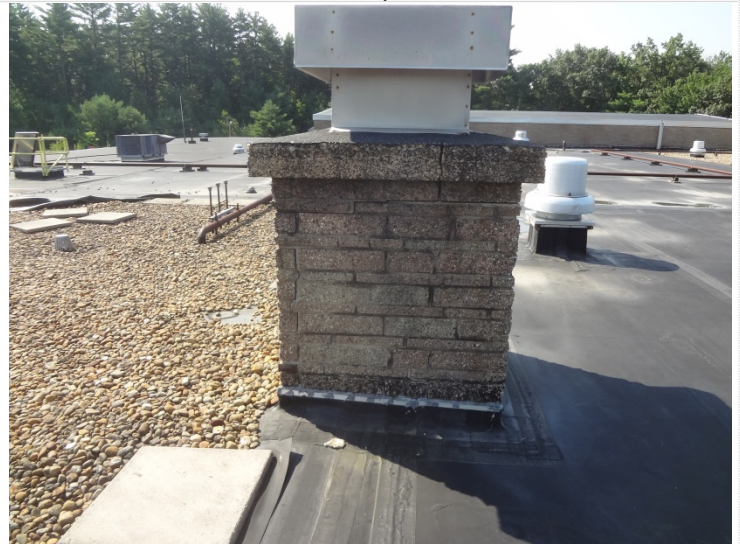
Cracked Chimney

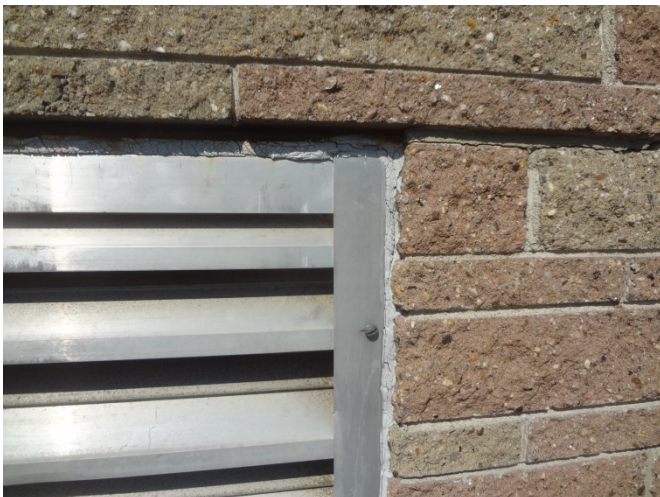
The majority of the sealant in the joints (both expansion and around openings) have reached the end of their useful life and should be replaced. The expansion joints in the walls should be cleaned out, a backer bar installed prior to the sealant being installed. Care should be exercised when selecting the sealant material to be used. All sealants used for vertical wall joints must conform to ASTM C920 which defines Type, Grade, Class and Use. Sealants are either type S (single component) or type M (multi-component). Grade NS (non-sag) which must be used for vertical wall joints. Sealants are defined by class which defines elongation capabilities. A Class 25 sealant can tolerate 25% expansion and contraction. A Class 100/50 sealant can tolerate 100% expansion and 50% contraction. Sealants are also classified by Use such as M, G, A or O, meaning that they have passed a series of tests demonstrating satisfactory adherence to mortar (M), glass (G), aluminum (A) or other materials (O). A sealant intended for use in an expansion joint between masonry and bein capable of 50% elongation would be specified as Type M, Grade NS, Class 50, Use M. There are three types of joint sealants typically used that can be applied with a sealant gun. Types sealants are;

Sealant at Louver

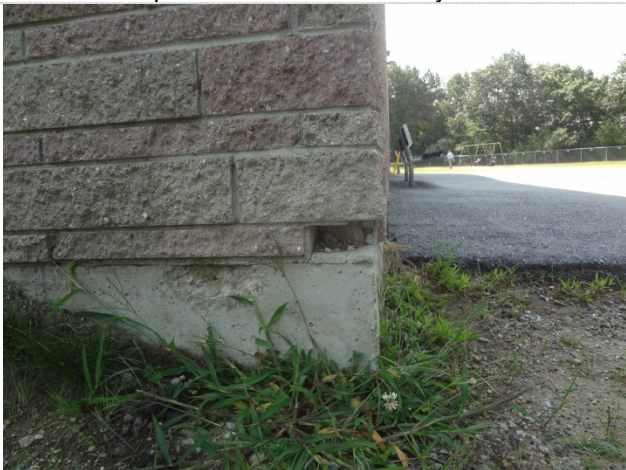
Missing Brick at Building Corner

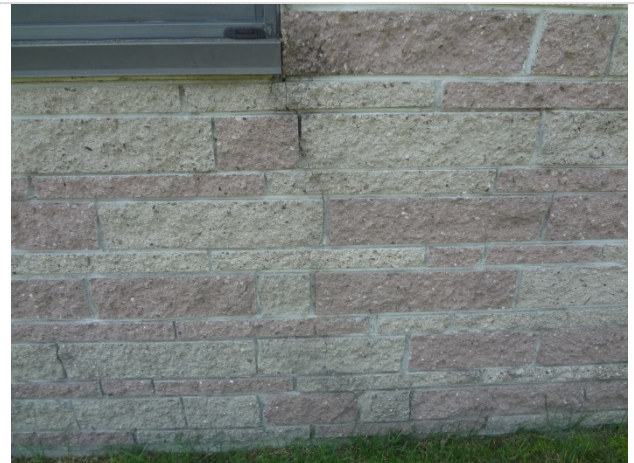
Step Crack at Masonry Veneer

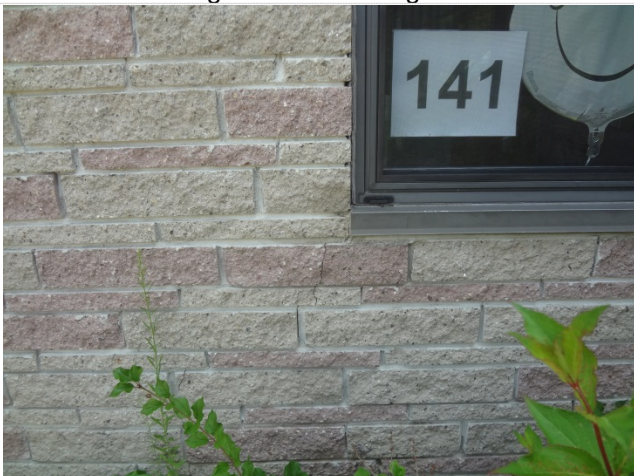
Step Crack in Masonry Veneer

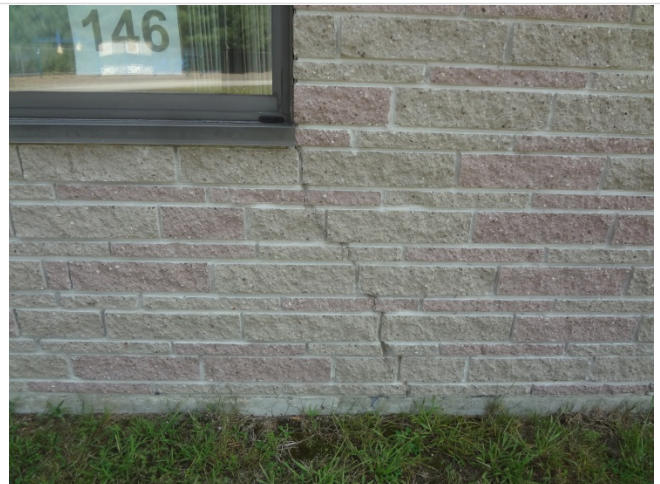
Step Crack in Masonry Veneer

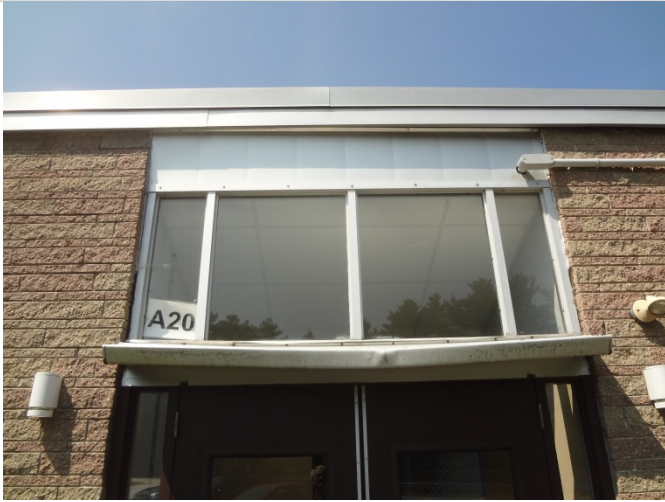
Damaged Roof at East Entry
