ASSESSMENT REPORT FOR:

FRED C. UNDERHILL ELEMENTARY
HOOKSETT, NEW HAMPSHIRE

TTG PROJECT No: 4297

DATE: AUGUST 29, 2017

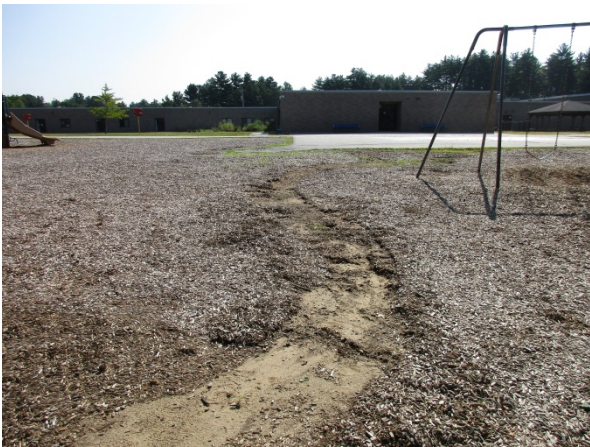
Erosion through playground mulch.

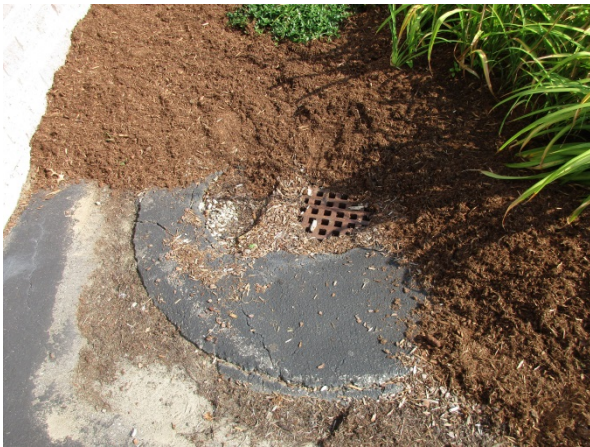
There is a catch basin adjacent to the main entrance intended to prevent runoff and snowmelt from ponding in front of the doorway, because the asphalt sidewalk slopes gradually toward the structure. It appears this is an infiltration catch basin because it is very shallow (12-24" deep) and there was no visible outlet pipe. The shallow depth may be due to an accumulation of sand, mulch, grass clippings, and other debris in the sump, which reduces the design capacity of the basin. The structure appears to have heaved vertically approximately 1-inch, creating a collar that prevents water from completely draining to the inlet.

Catch basin adjacent to main building entrance.

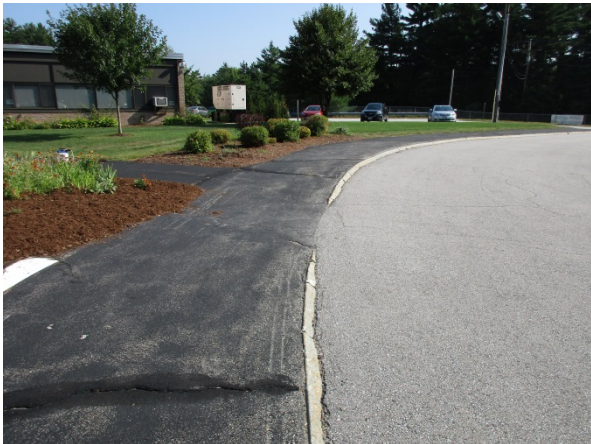
Sidewalk tip down- install a concrete accessible tip down compliant with ADA regulations.

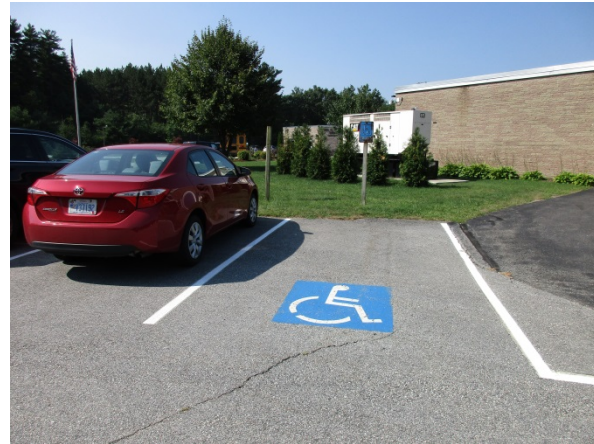
Noncompliant accessible space- no adjacent access aisle and sign is mounted too low.

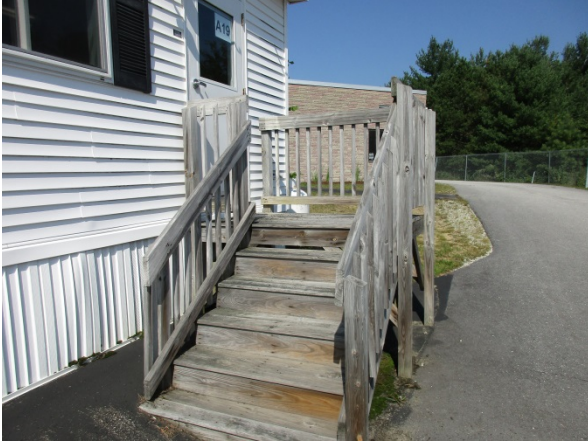
Reconstruct stairs (both sets) to the portable classrooms to be in compliance with ADA regulations. In their current configuration the risers are too tall and the railings are noncompliant.

- Replace wooden stairs and railings leading to the portable classroom.

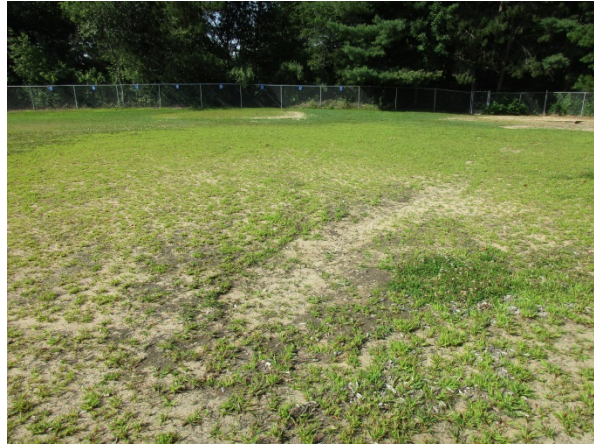
Sparse vegetation in playground (typical)

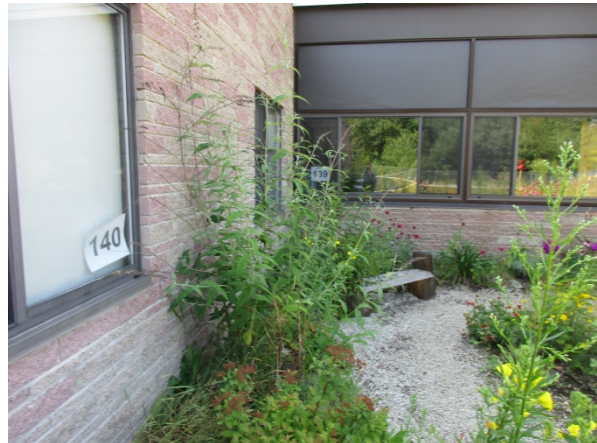
Overgrowth at flower garden.

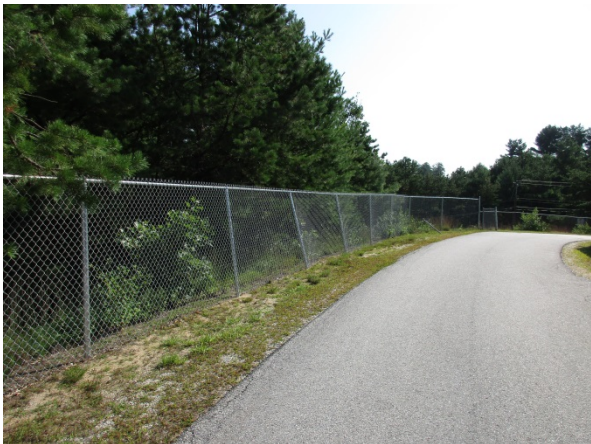
Displaced fence.

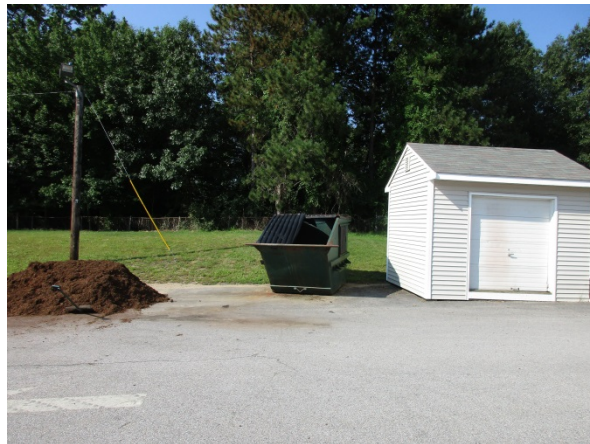
Install concrete dumpster pad & approach apron,
plus an opaque enclosure.

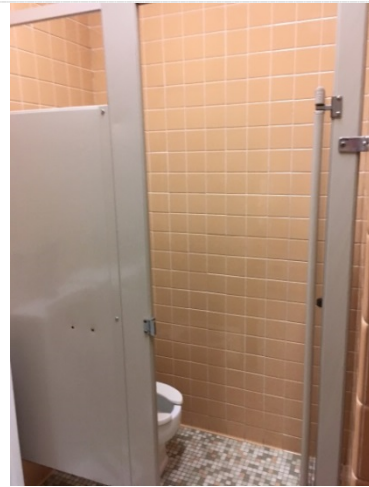
Dated Restrooms

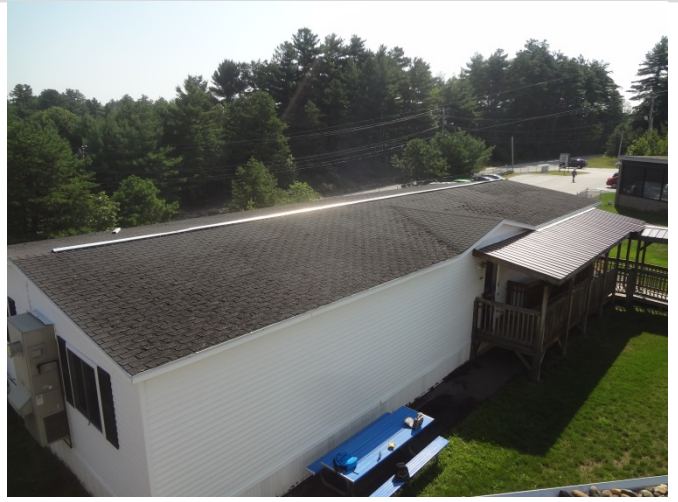
Portable Roof Shingles

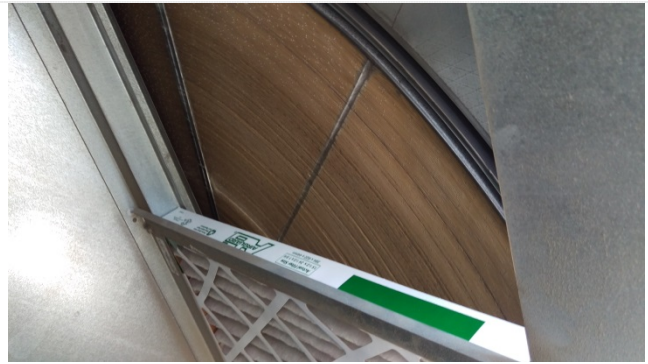
Dirt on ERU exchange Wheel.

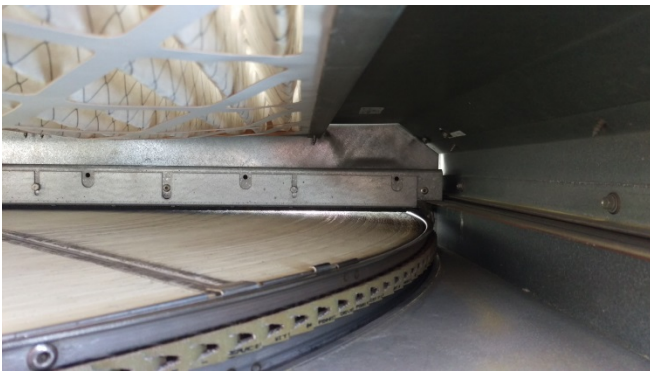
ERU gap in seal between Supply & Exhaust.

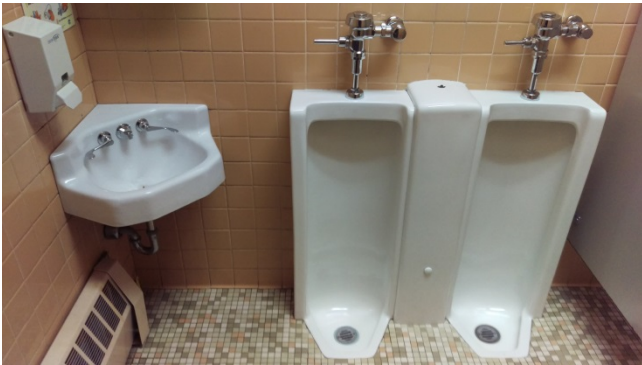
Original Plumbing Fixtures
